Manhole Inspection Summary

Manhole # S43KK_042MH

Insp Date: **8/13/08 8:31 AM**

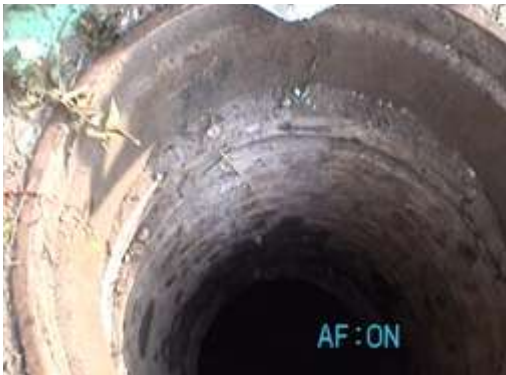
Defect 2

Frame Offset: **2** (in.) Condition: ☐ Sound ☐ Cracked ☒ **Leaks**

Frame leaks

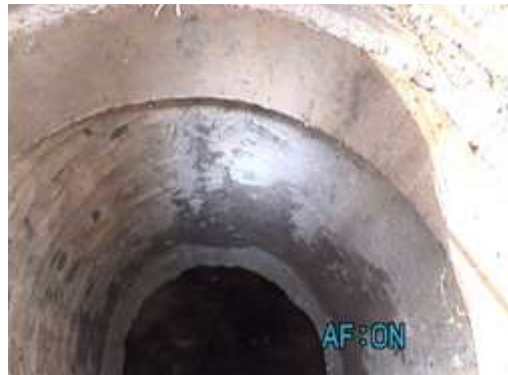
Defect 1

Infiltration: ☐ None ☐ Joint ☐ Cracks ☒ **Mortar** ☐ Roots ☐ Wall

Infiltration: ☐ None ☐ Joint ☐ Cracks ☐ Mortar ☐ Roots ☒ **Wall**

Infiltration

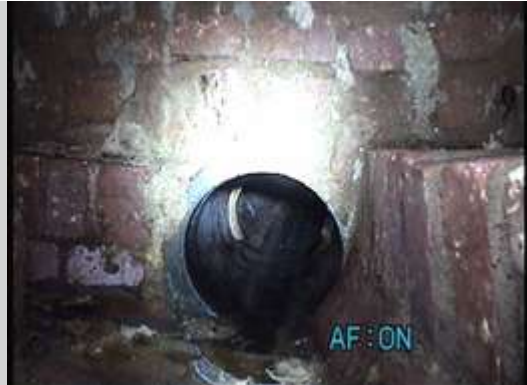
12 O'Clock Outflow

8 in. Circular Gravity Sewer
Pipe Out @ 12 O'Clock

Pipe Height: **8.4** (in.) Rod and Bar (Angled)
Pipe Material: **Clay** ☐ Pipe Lined
Invert Depth: **9.50** (ft.) Flow Characteristics: **Fast**
Deposits: ☒ None ☐ Mud ☐ Sludge ☐ Debris ☐ Grease
Silt Depth: (in.) Deposits Extent:
Infiltration: **None** Pipe Seal Cond: **Sound**

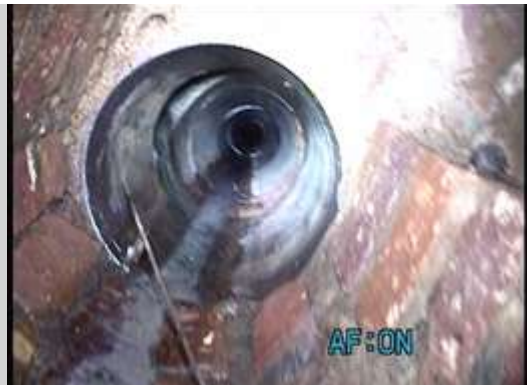
3 O'Clock Inflow

8 in. Circular Gravity Sewer
Pipe In @ 3 O'Clock

Pipe Height: **8.4** (in.) Rod and Bar (Angled)
Pipe Material: **Clay** ☐ Pipe Lined
Invert Depth: **9.45** (ft.) Flow Characteristics: **Fast**
Deposits: ☒ None ☐ Mud ☐ Sludge ☐ Debris ☐ Grease
Silt Depth: (in.) Deposits Extent:
Infiltration: **None** Pipe Seal Cond: **Sound**

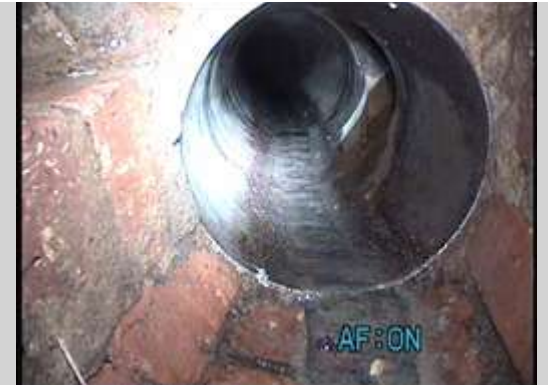
9 O'Clock Inflow

8 in. Circular Gravity Sewer

Pipe In @ 9 O'Clock

Infiltration: **None** Pipe Seal Cond: **Sound**
